GEOTECHNICAL APPENDIX UPPER YORK CREEK ECOSYSTEM RESTORATION PROJECT ST. HELENA, CALIFORNIA

1.0 INTRODUCTION

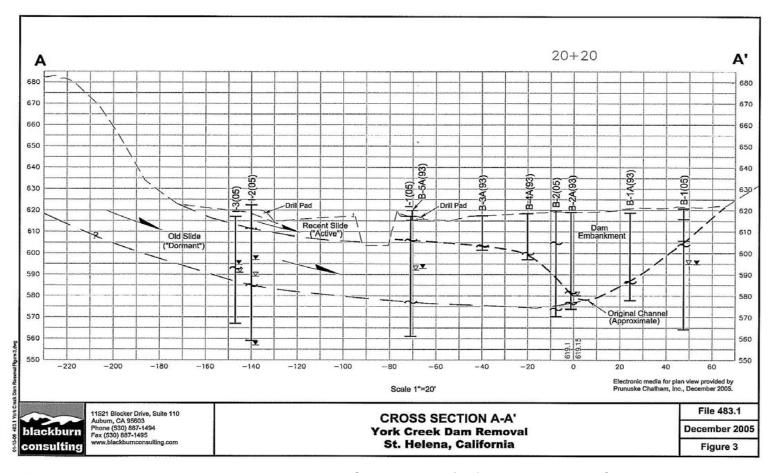
Figure 2. Transverse section along the dam embankment at Station 20+20. (Reference: Blackburn Consulting Inc. 2006. Geotechnical Data Report prepared for the City of St. Helena).

Figure 2 shows the cross section drawn along in a transverse direction from Spring Mountain Road to the crest of the dam. Subsurface conditions within the dam embankment consisted of fill overlying serpentinite bedrock. Natural undisturbed slope of the bedrock on the right, as looking downstream, abutment above the dam is estimated at about 1.4 H to 1V slope (horizontal to vertical) and steeper in other areas. The steepness of this slope is likely attributed to the presences of Franciscan sandstone, mapped as Kjfs in MF-483; although not investigated for this project, as the slope is steeper than the sheared Franciscan shale would likely support.

Two failure planes labeled as recent slide ("active") and old slide ("dormant") are shown in cross section A-A of Figure 2. These interpreted landslides can be found in the January 16, 2006 Geotechnical Data Report prepared by Blackburn Consulting for the City of St. Helena. The interpreted location of the old dormant slide is approximately between 30 and 40 feet below the existing ground surface while the recent slide failure plane appears to pass just above the bottom of the spillway. The reviewer from USACE Los Angeles District questioned whether a failure plane exists where it is shown in cross-section A-A. Another interpretation of existing slides can be seen on Figure C-1 of the USACE Sacramento District report dated March 15, 2005. In this case, the predicted slide corresponding to a factor of safety of 1.0 is limited only in the road cut while the slides presented in cross- section A-A extend deeper and beyond the road and into the dam embankment. The difference in interpretation suggests that it is extremely difficult to predict past and future slides if one is to rely on limited boring information.

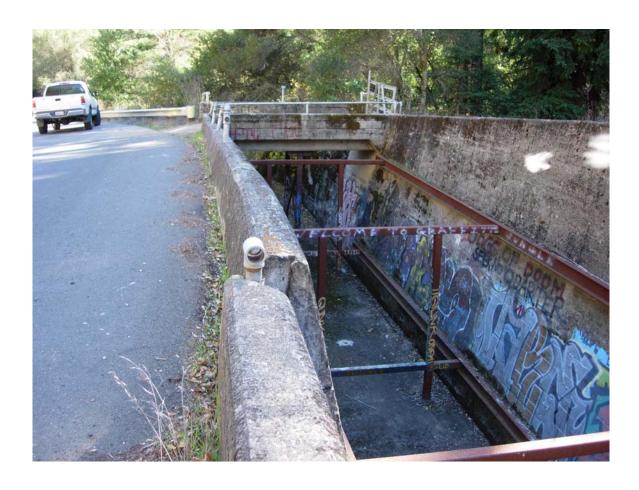
Figure 3. Observed spillway wall movement adjacent to Spring Mountain Road (November 17, 2005).

Following the stability analyses, it is recognized that even when the factors of safety appear to be within acceptable limit the ground area near the dam and spillway has apparently experienced some movement as evident from the lateral displacement of the spillway left chute wall (USACE site visit report, 2005). This observed movement is shown in **Figure 3.** It should

be noted that the movement of one spillway wall is not being used as evidence of a slope stability problem impacting Spring Mountain Road. The spillway wall has apparently experienced some movement since it was constructed. A steel supporting framework is acting against additional displacement. Unless a record of on-going monitoring measurements to support the observation, displacement could also have resulted from heavy road construction equipment working too close to the wall and other unknown site activities. Personal experience by the reviewer from the USACE Los Angeles District with retaining wall constructed for the Arizona Canal Diversion Channel in Phoenix, Arizona had similar deflection caused by water pushing between the wall and the backfill. These movements occurred during storm events when significant flows were going over the walls. The examples given here suggest that there are certainly a number of possibilities that could cause the spillway wall to move. accurate field procedure to measure the amount of lateral movement is through the use of an inclinometer. An inclinometer is a device made of flexible casing that is installed vertically into a borehole, with an inclinometer probe lowered into the casing to measure the lateral deformation of the ground. The monitoring of installed slope inclinometers may help to answer the question of current on-going movement. Preliminary baseline data from 3 inclinometers as well as groundwater measurements are provided in **Appendix G2**.

- (1) Removal of all or portion of the existing dam is expected to have no adverse impact on the road or left abutment concrete spillway. However, the spillway should be left in-place and backfilled to provide continued lateral support for the road.
- (2) Minimize the excavation just to allow for adequate fish passage. Side slopes should be excavated no steeper than 1.5H:1V.
- (3) Erosion protection should be placed at the toe of the new excavated slopes.
- (4) Additional explorations and stability analyses for both large scale and small abutment slides are recommended for the final design.
- (5) Implement an instrumentation program to monitor for slope movement.
